Rocky Flats Environmental Technology Site

RECONNAISSANCE LEVEL CHARACTERIZATION REPORT (RLCR) SUPPLEMENT

BUILDING 771 CLOSURE PROJECT

REVISION 1

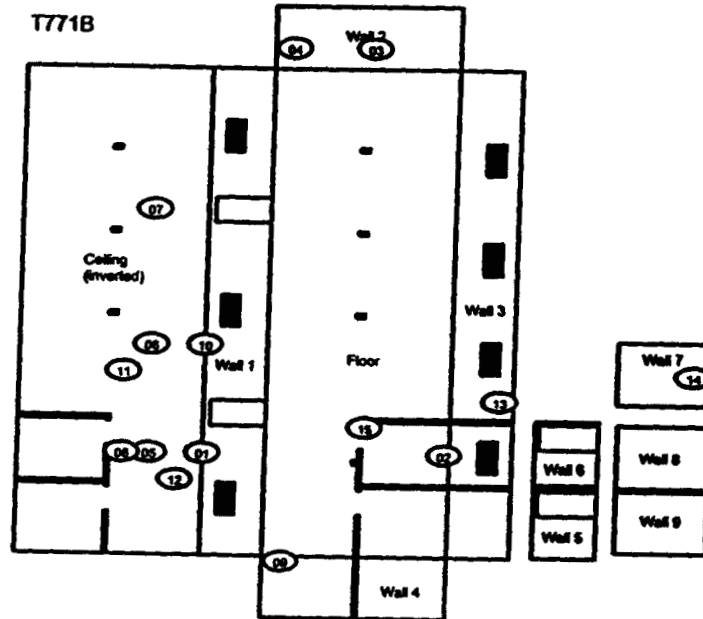
SURVEY UNIT 771003 - MAP 1 OF 1

Survey Area: AJ Survey Unit: 771003 Classification: 3
 Building: T771B
 Survey Unit Description: T771B Interior
 Total Floor Area: 122 sq. m Total Area: 386 sq. m Grid Size: N/A

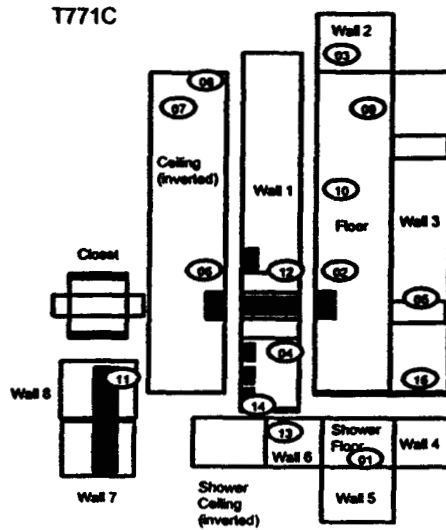
SURVEY UNIT 771004 - MAP 1 OF 1

Survey Area: AJ Survey Unit: 771004 Classification: 3
 Building: T771C
 Survey Unit Description: T771C Interior
 Total Floor Area: 37.3 sq. m Total Area: 150 sq. m Grid Size: N/A

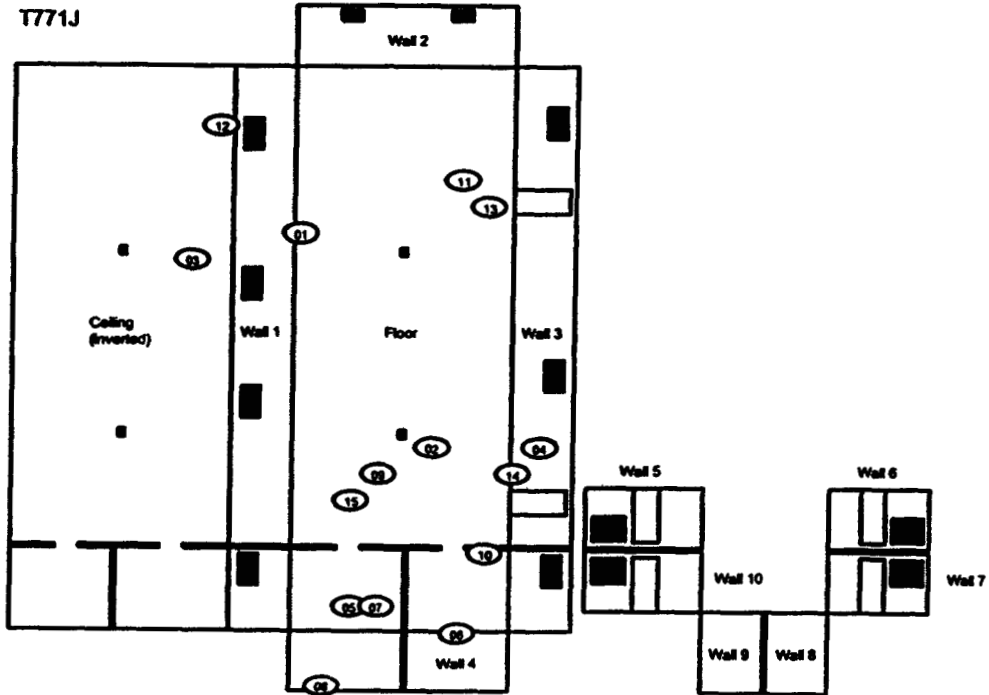
SURVEY UNIT 771008 - MAP 1 OF 1

Survey Area: AJ Survey Unit: 771008 Classification: 3
 Building: T771J
 Survey Unit Description: T771J Interior
 Total Floor Area: 170 sq. m Total Area: 512 sq. m Grid Size: N/A

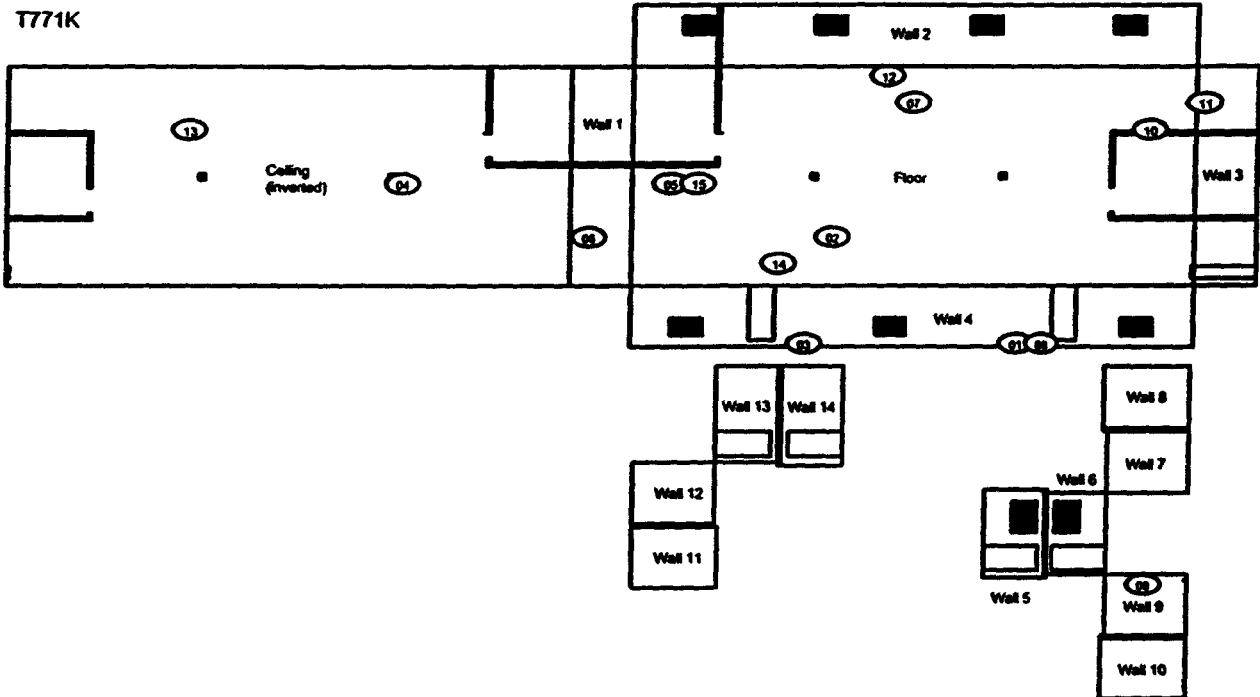
SURVEY UNIT 771009 - MAP 1 OF 1

Survey Area: AJ Survey Unit: 771009 Classification: 3
 Building: T771K
 Survey Unit Description: T771K Interior
 Total Floor Area: 169 sq. m Total Area: 537 sq. m Grid Size: N/A

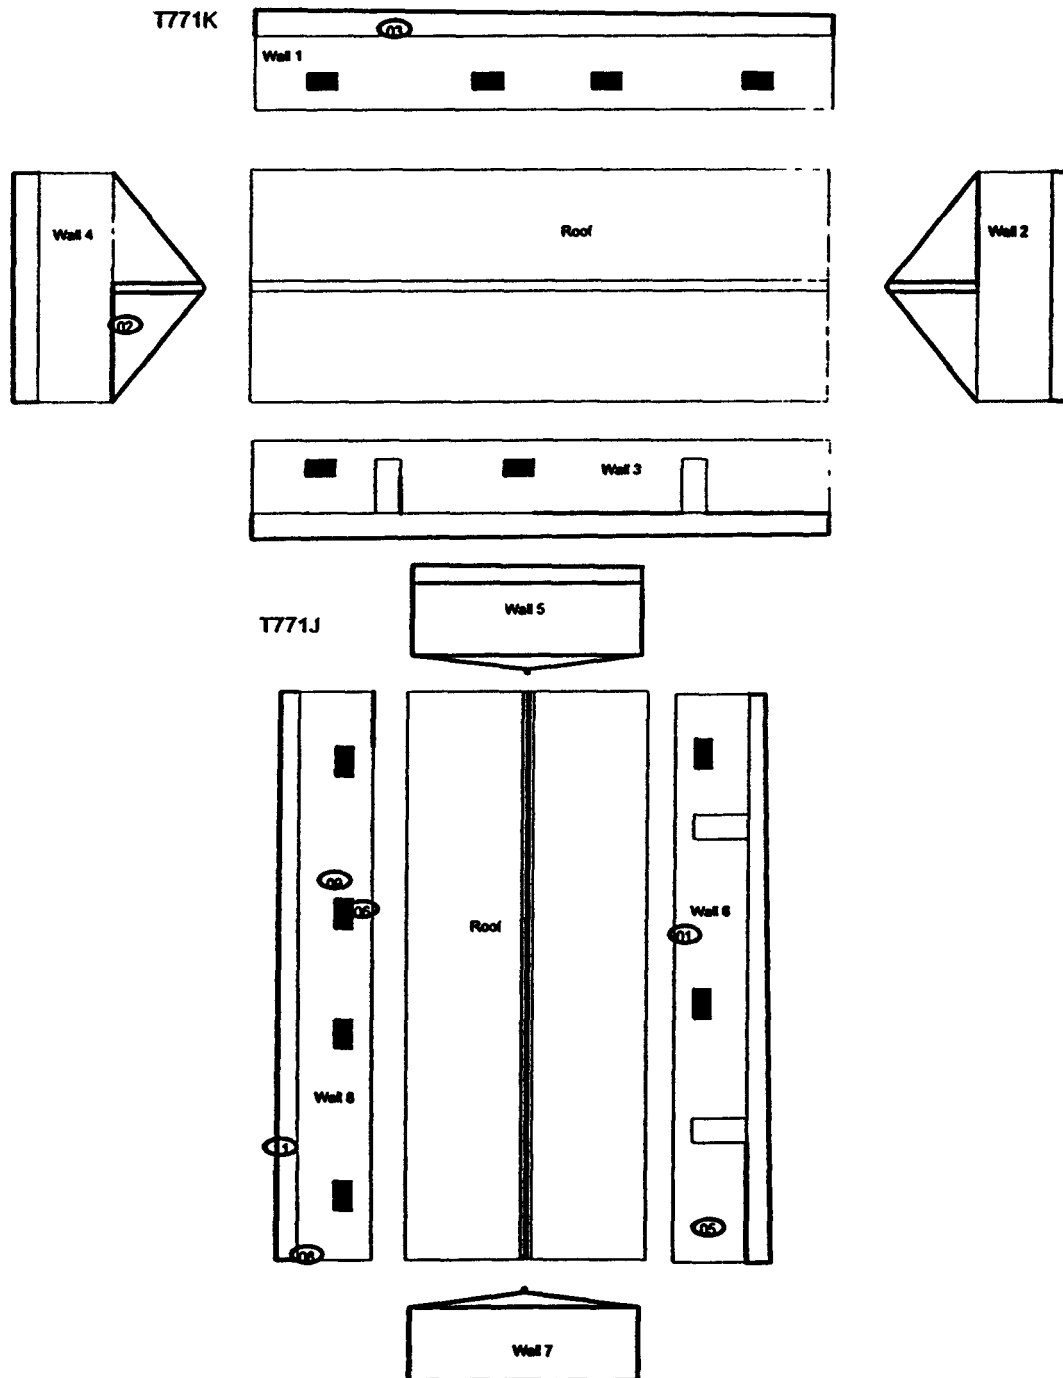
SURVEY UNIT 771010 - MAP 1 OF 2

Survey Area: Survey Unit: 771010 Classification: 2
 Building: 771
 Survey Unit Description: 771 Trailers K, J, E, H External Surfaces
 Total Floor Area: NA sq. m Total Area: 1216 sq. m Grid Size: N/A

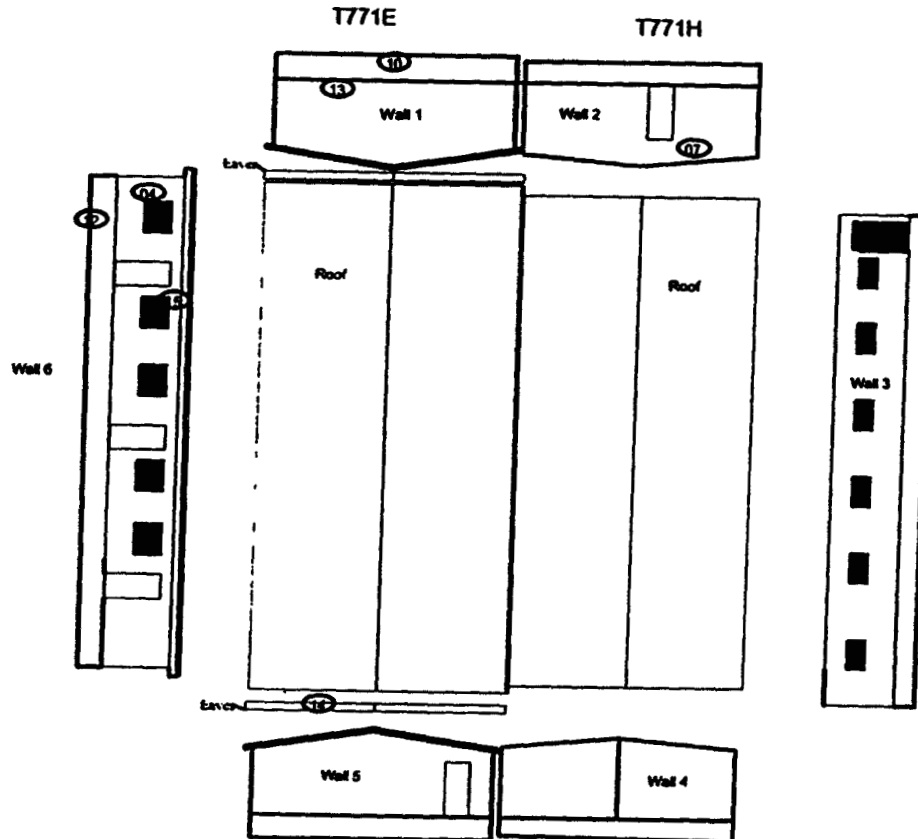
SURVEY UNIT 771010 - MAP 2 OF 2

Survey Area: AJ Survey Unit: 771010 Classification: 3
 Building: 771
 Survey Unit Description: 771 Trailers K, J, E, H External Surfaces
 Total Floor Area: NA sq. m Total Area: 1216 sq. m Grid Size: N/A

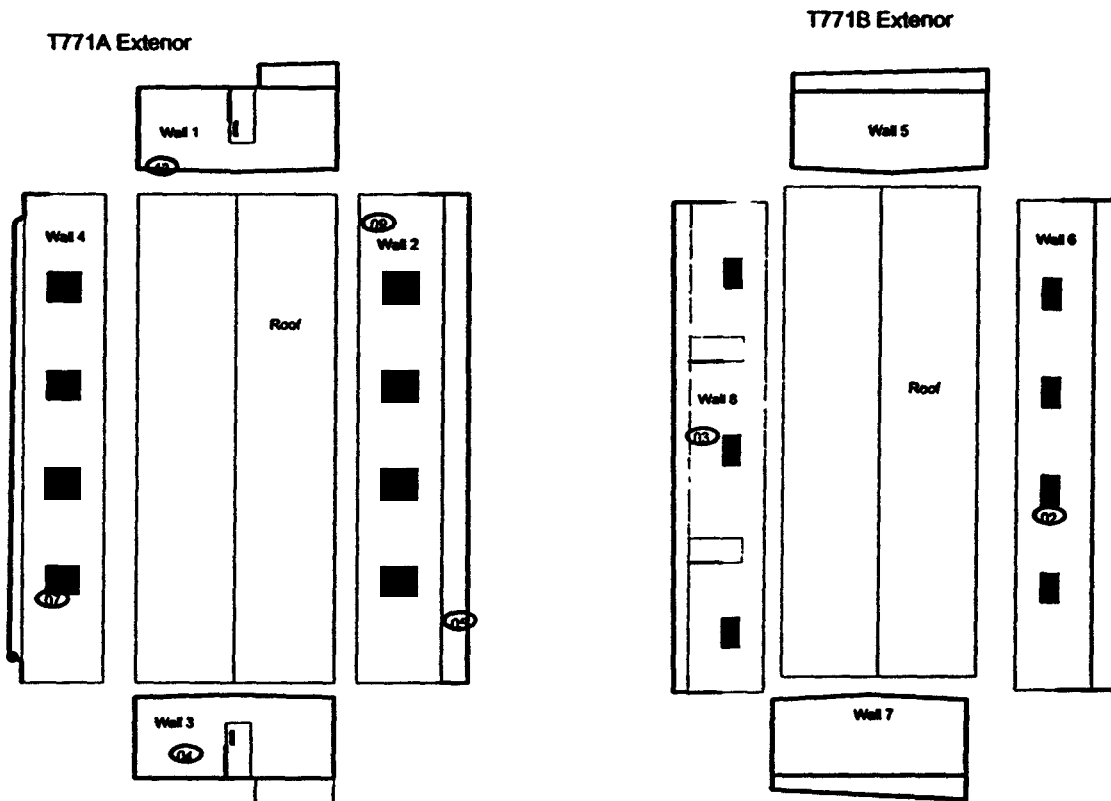
SURVEY UNIT 771011 - MAP 1 OF 2

Survey Area: AJ Survey Unit: 771011 Classification: 3
 Building: T771 A, B, C, G
 Survey Unit Description: T771 A, B Exterior
 Total Floor Area: NA Total Area: 1106 sq. m Grid Size: N/A

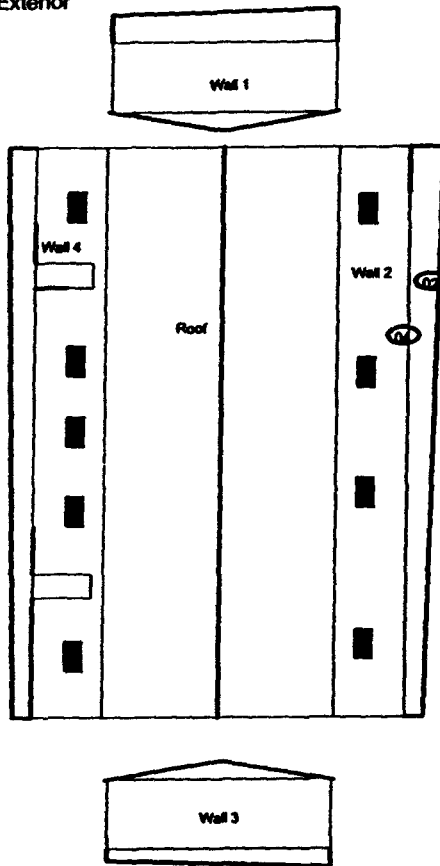
SURVEY UNIT 771012 - MAP 2 OF 2

Survey Area: AJ Survey Unit: 771012 Classification: 3
 Building: 771
 Survey Unit Description: T771F Interior/Exterior
 Total Floor Area: 162 sq. m Total Area: 1031 sq. m Grid Size: N/A

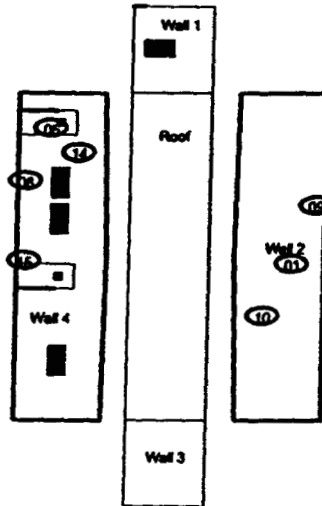
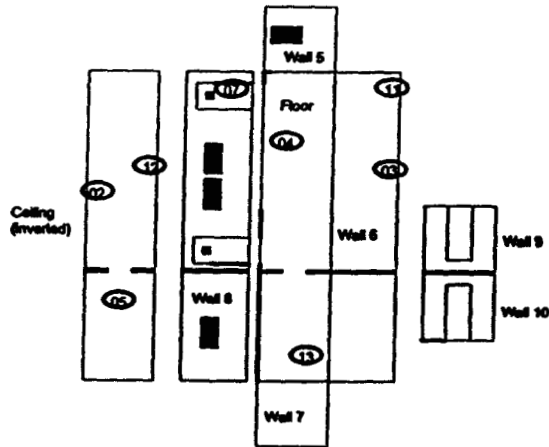
SURVEY UNIT 771014 - MAP 1 OF 1

Survey Area: AJ Survey Unit: 771014 Classification: 3
 Building: T771MB
 Survey Unit Description: T771MB Exterior/Interior
 Total Floor Area: 30 sq. m Total Area: 271 sq. m Grid Size: N/A

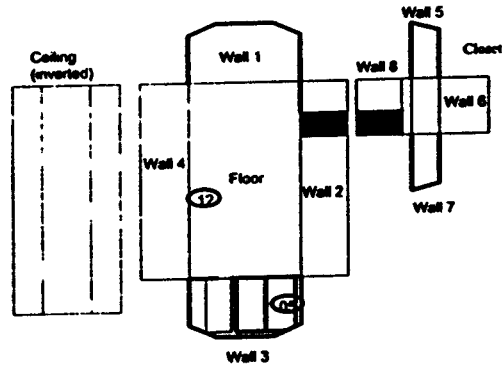
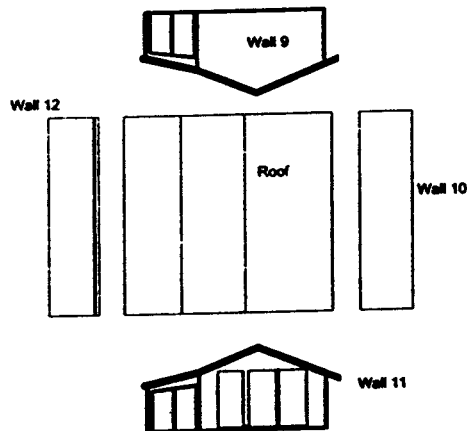
Survey Area: AJ Survey Unit: 771019 Classification: 3
 Building: 771B/770
 Survey Unit Description: 771B Interior/Exterior
 Total Floor Area: 303 sq. m Total Area: 2094 sq. m Grid Size: NA

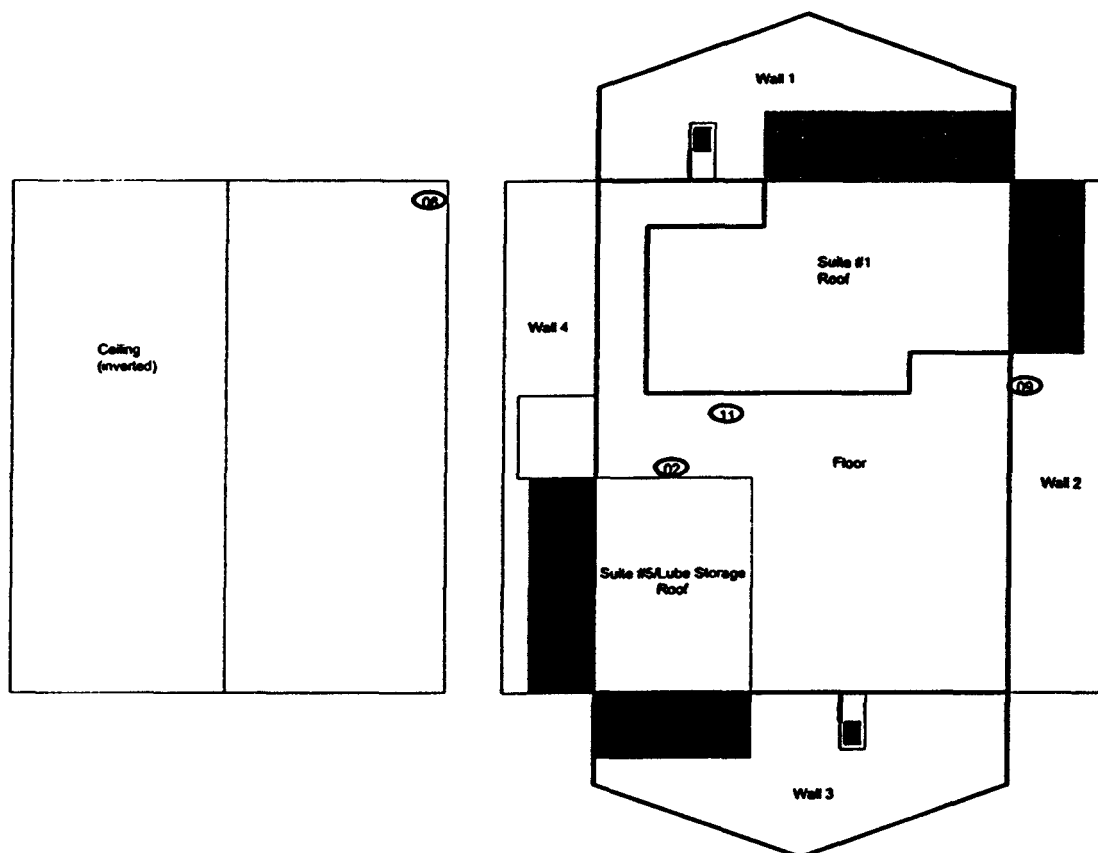
Survey Area: AJ **Survey Unit:** 771019 **Classification:** 3
Building: 771B / 770
Survey Unit Description: 770 Interior

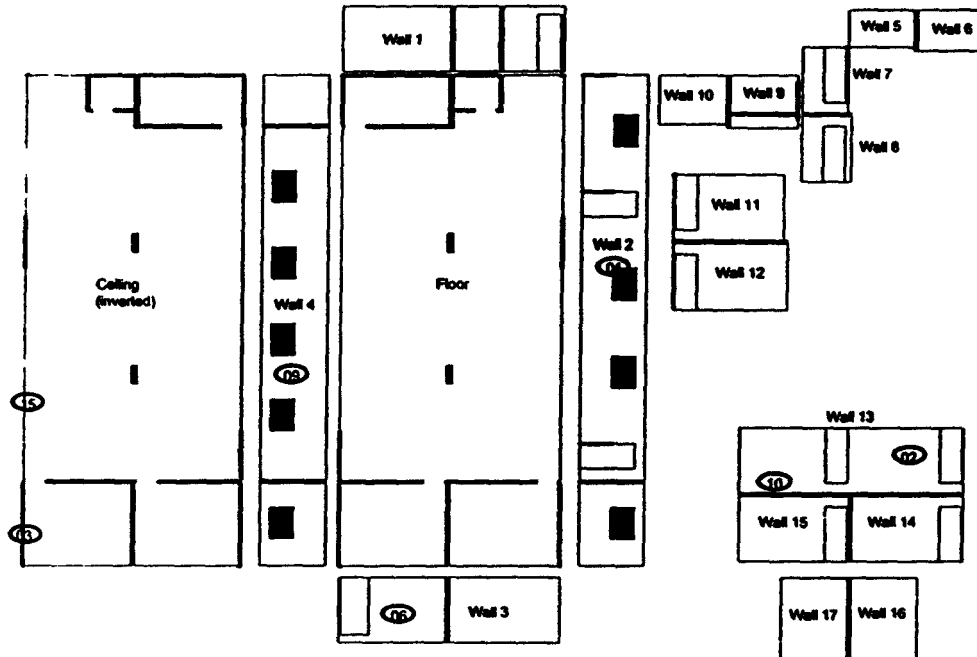
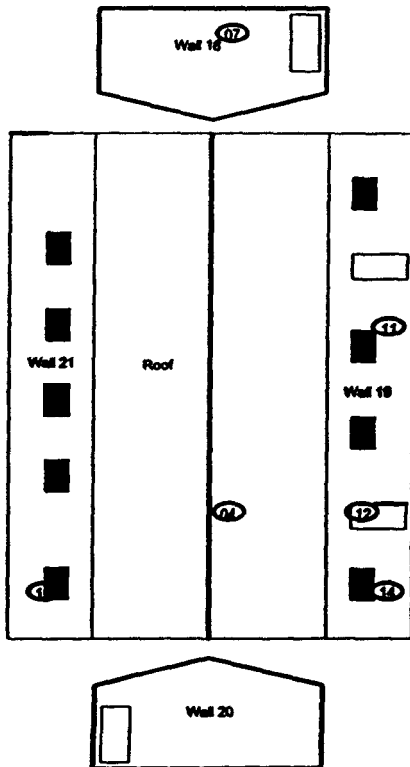
Survey Area: AJ Survey Unit: 771030 Classification: 3
 Building: T771R, T771-DT
 Survey Unit Description: Exterior/Interior
 Total Floor Area: 159 sq. m Total Area: 957 sq. m Grid Size: N/A

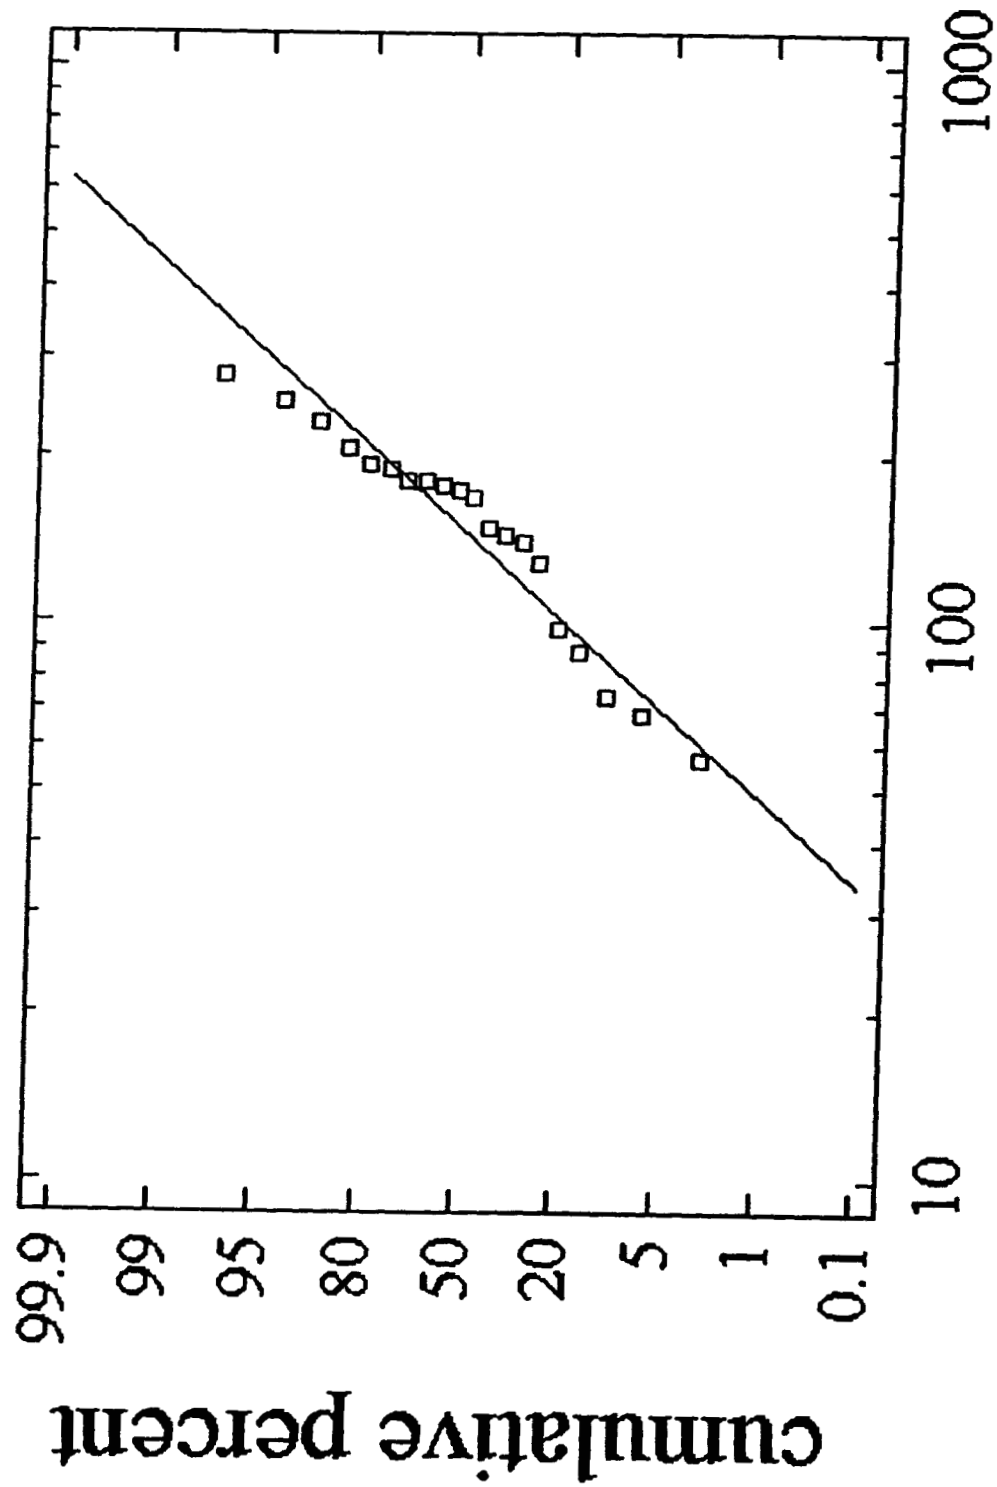
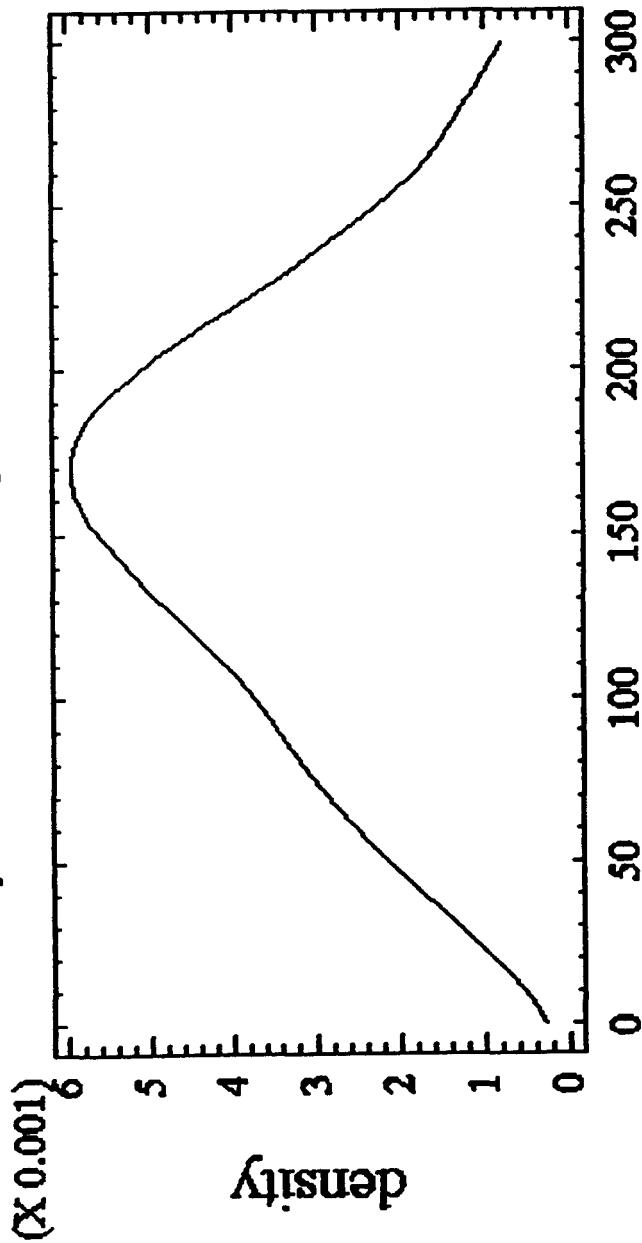
Lognormal Probability Plot

Since the smallest P-value amongst the tests performed is greater than or equal to 0.10, we can not reject the idea that Survey Unit 779010 dpm comes from a lognormal distribution with 90% or higher confidence.

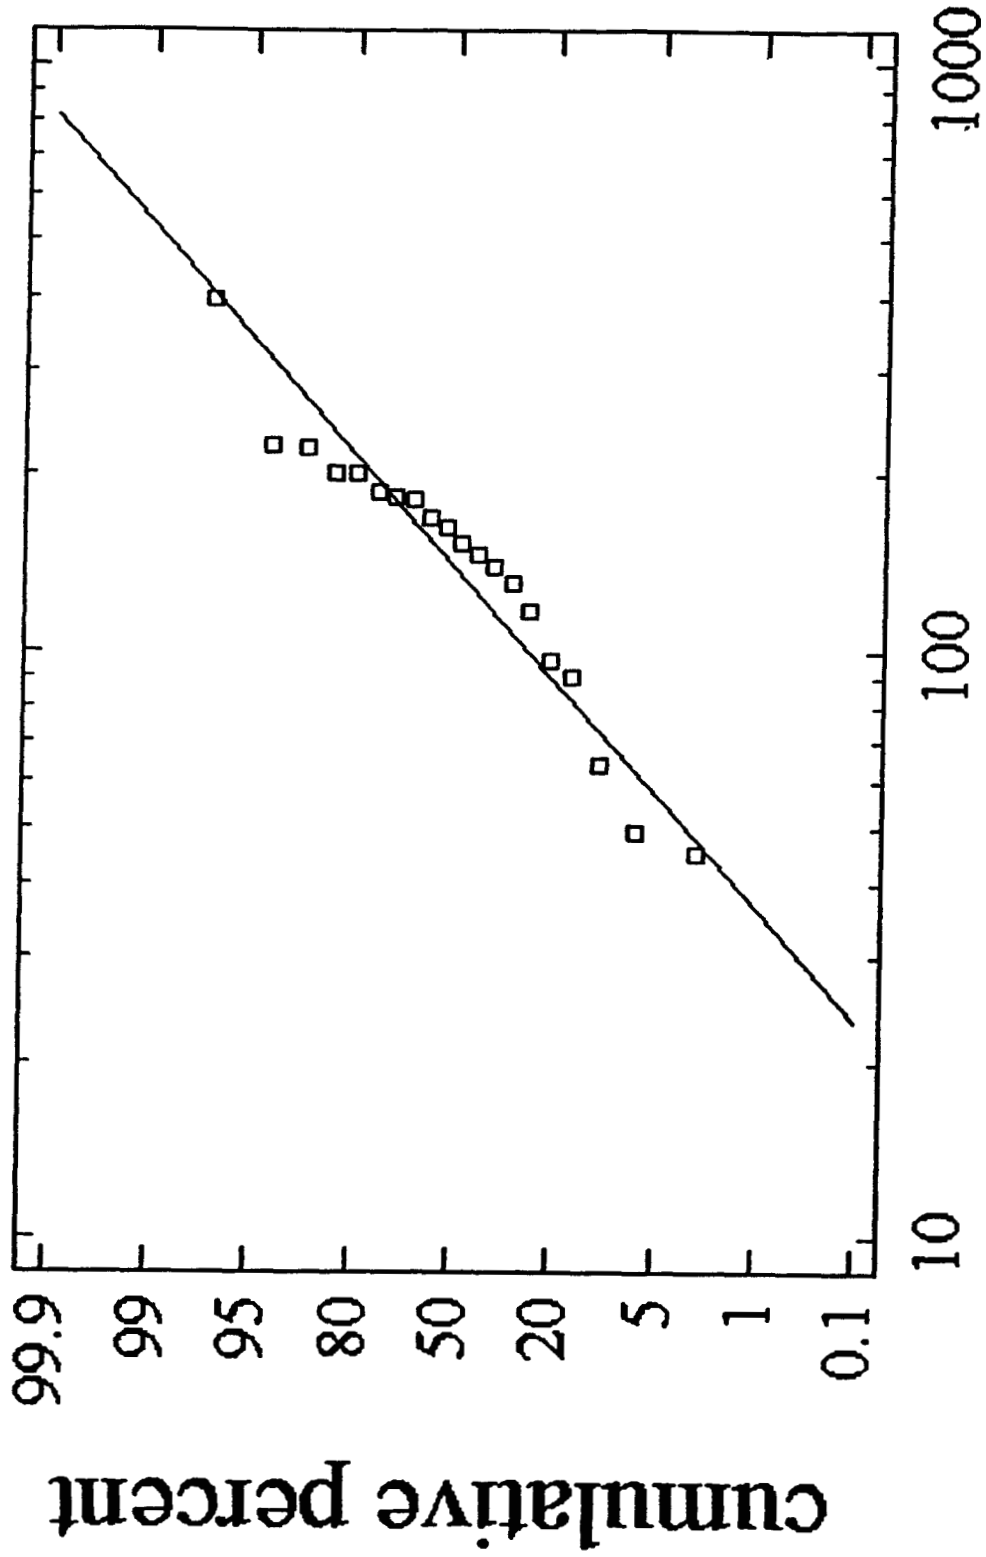
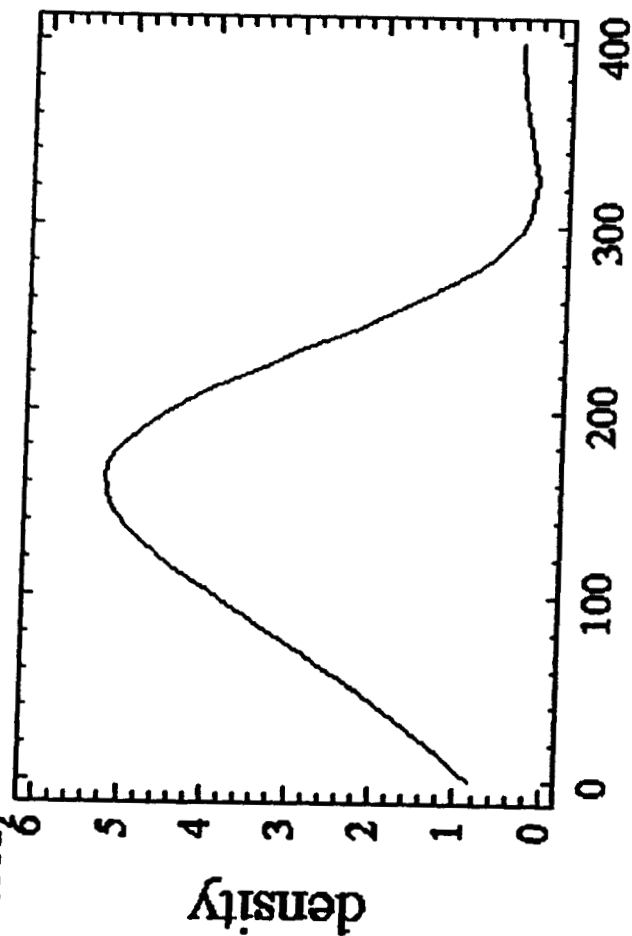
Lognormal Probability Plot

Since the smallest P-value amongst the tests performed is greater than or equal to 0.10, we can not reject the idea that Survey Unit 779011 dpm comes from a lognormal distribution with 90% or higher confidence.

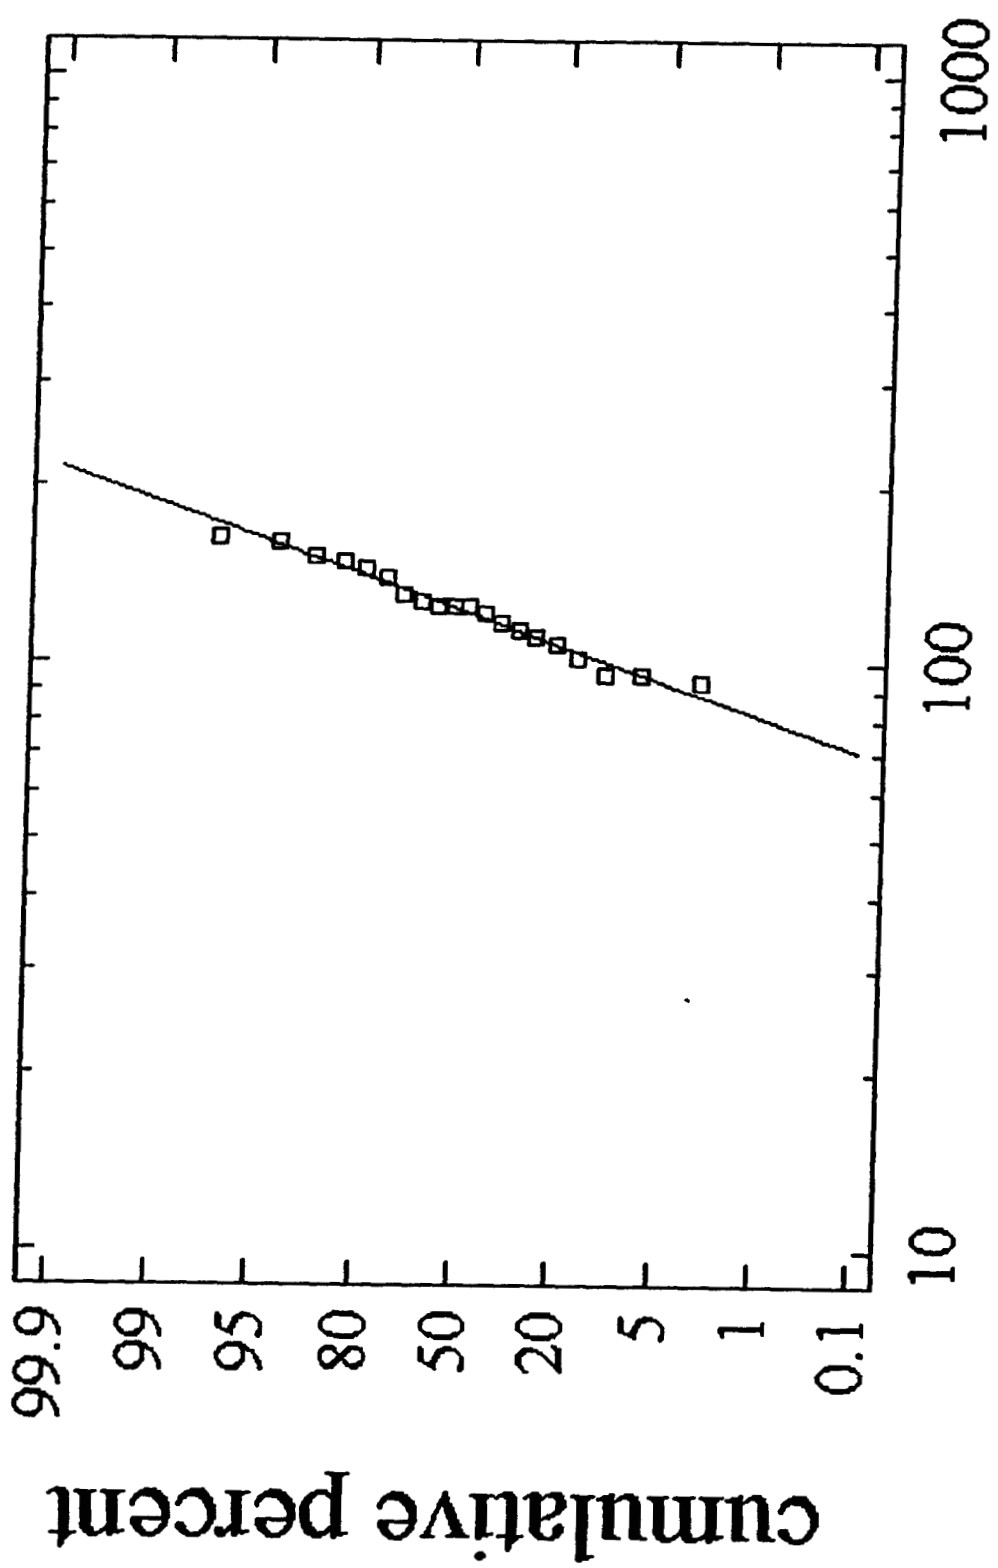
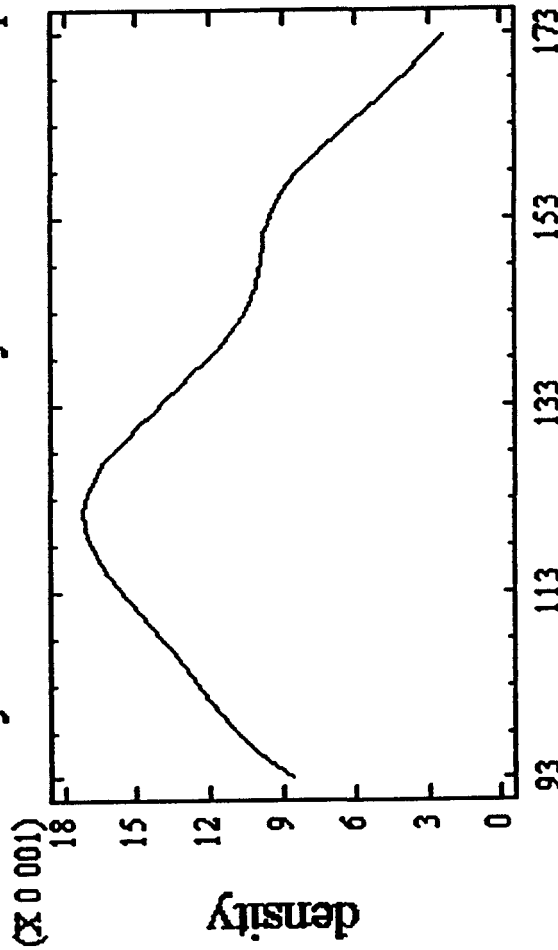
Lognormal Probability Plot

Since the smallest P-value amongst the tests performed is greater than or equal to 0.10, we can not reject the idea that Survey Unit 779012 dpm comes from a lognormal distribution with 90% or higher confidence.

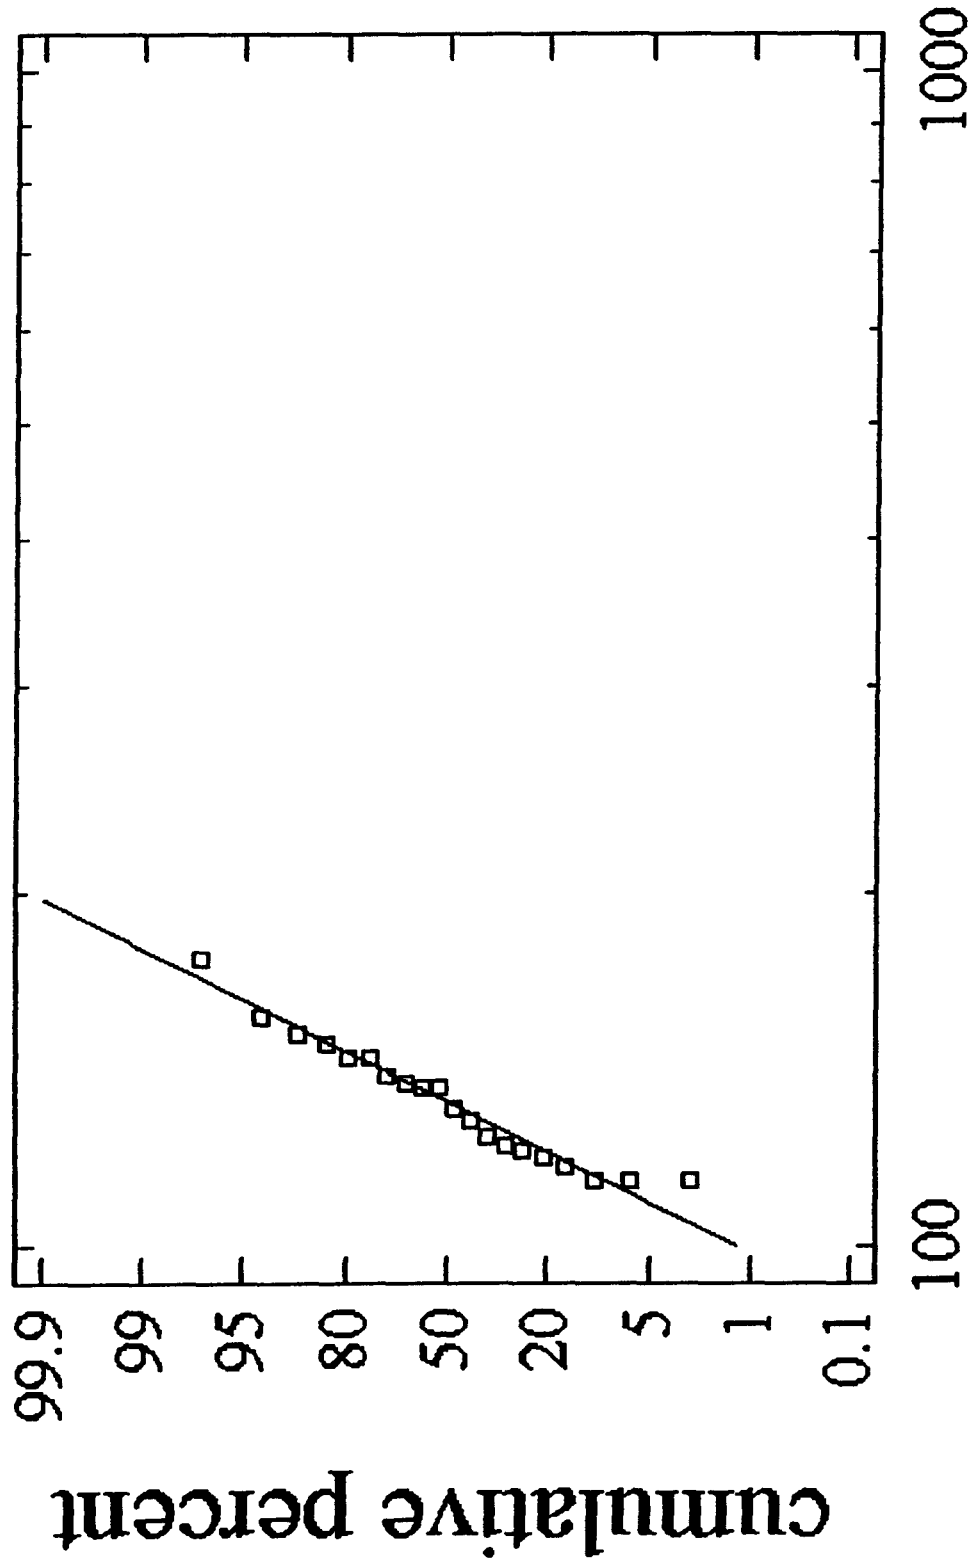
Lognormal Probability Plot

Since the smallest P-value amongst the tests performed is greater than or equal to 0.10, we can not reject the idea that Survey Unit 779013 dpm comes from a lognormal distribution with 90% or higher confidence.

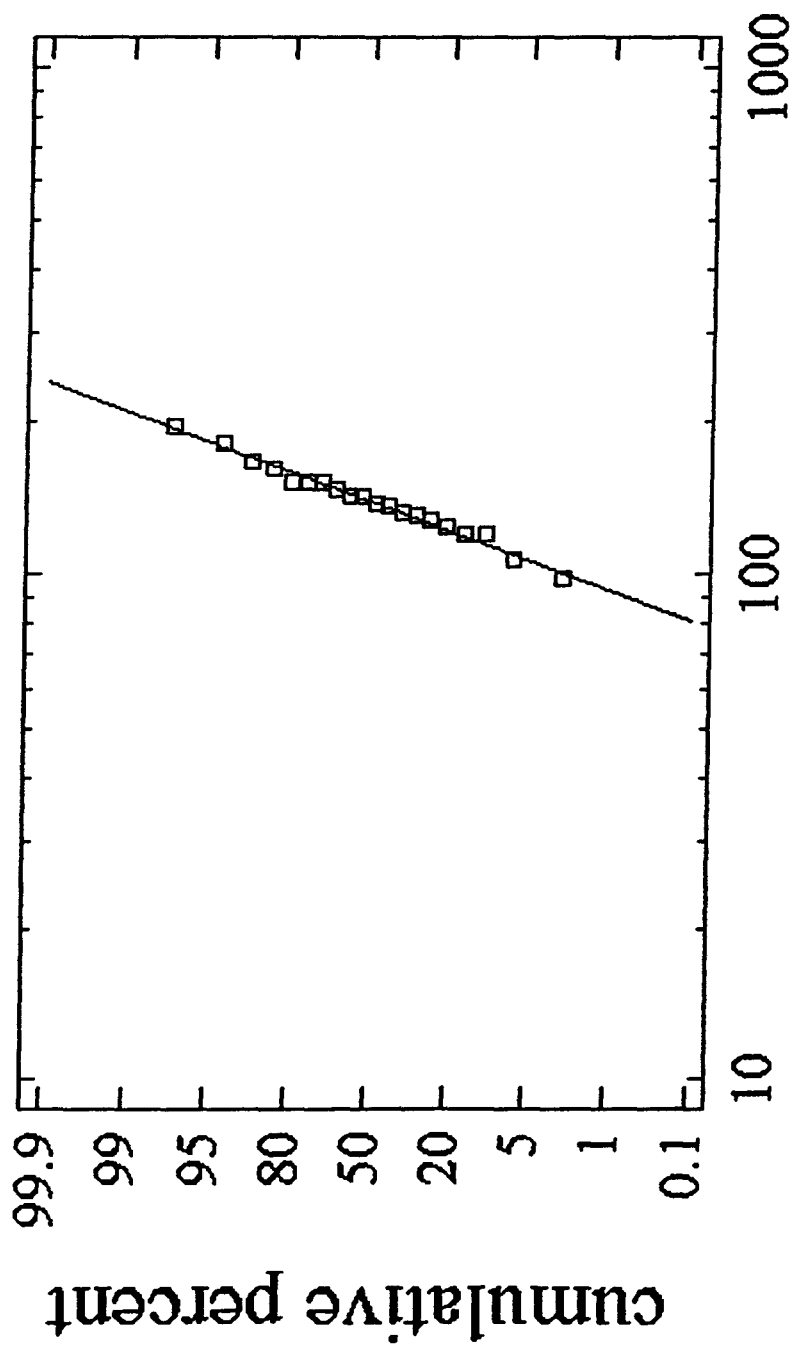
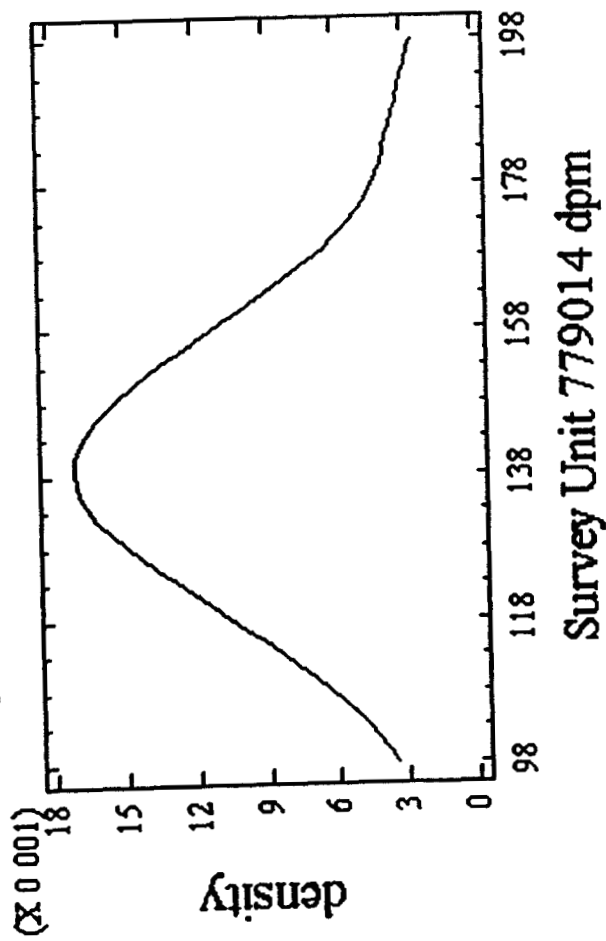
Lognormal Probability Plot

Since the smallest P-value amongst the tests performed is greater than or equal to 0.10, we can not reject the idea that Survey Unit 779014 dpm comes from a lognormal distribution with 90% or higher confidence.

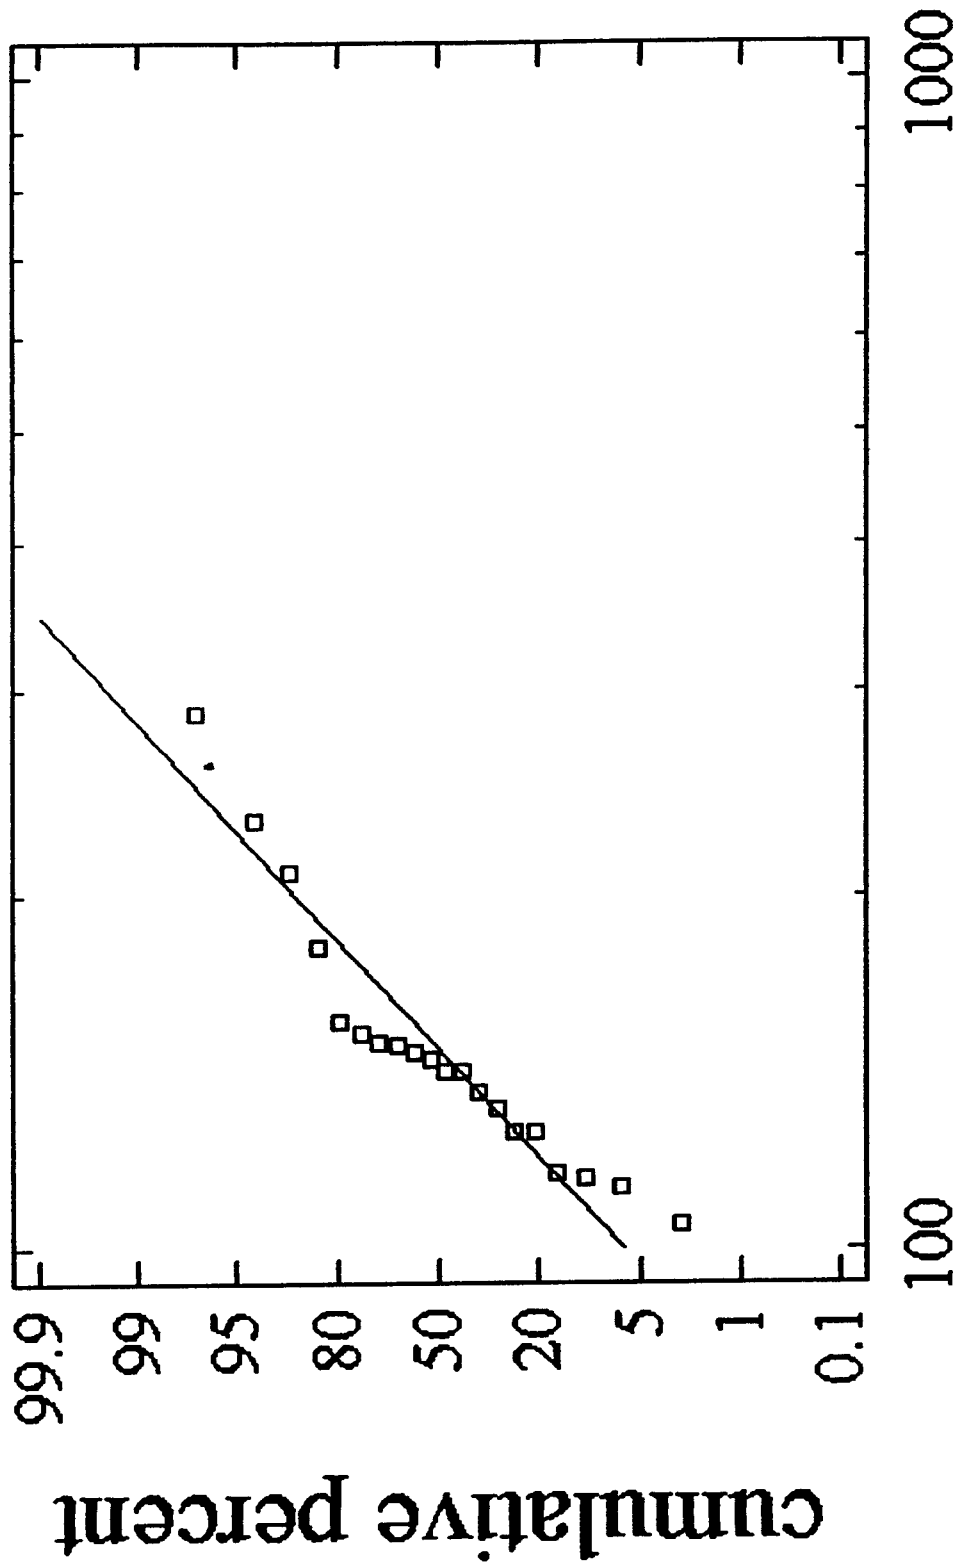
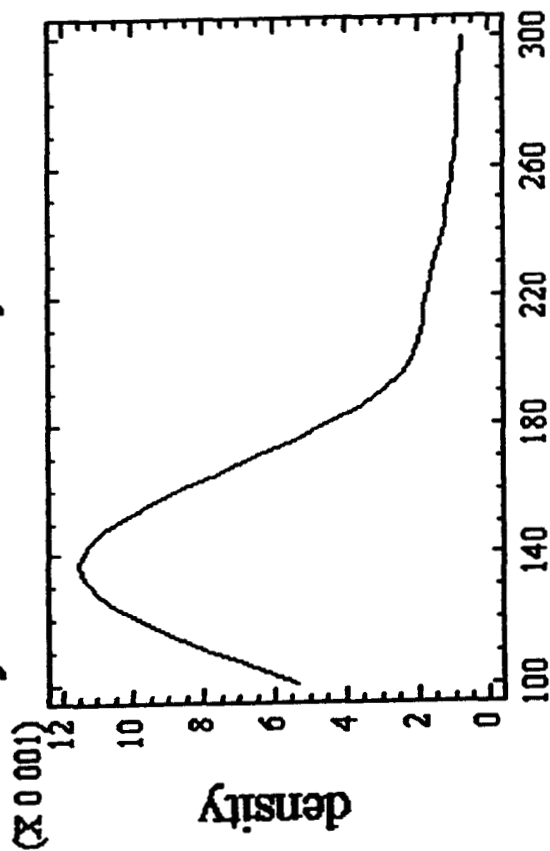
Lognormal Probability Plot

Since the smallest P-value amongst the tests performed is less than 0.10, we can reject the idea that Survey Unit 779016 dpm comes from a lognormal distribution with 90% confidence.

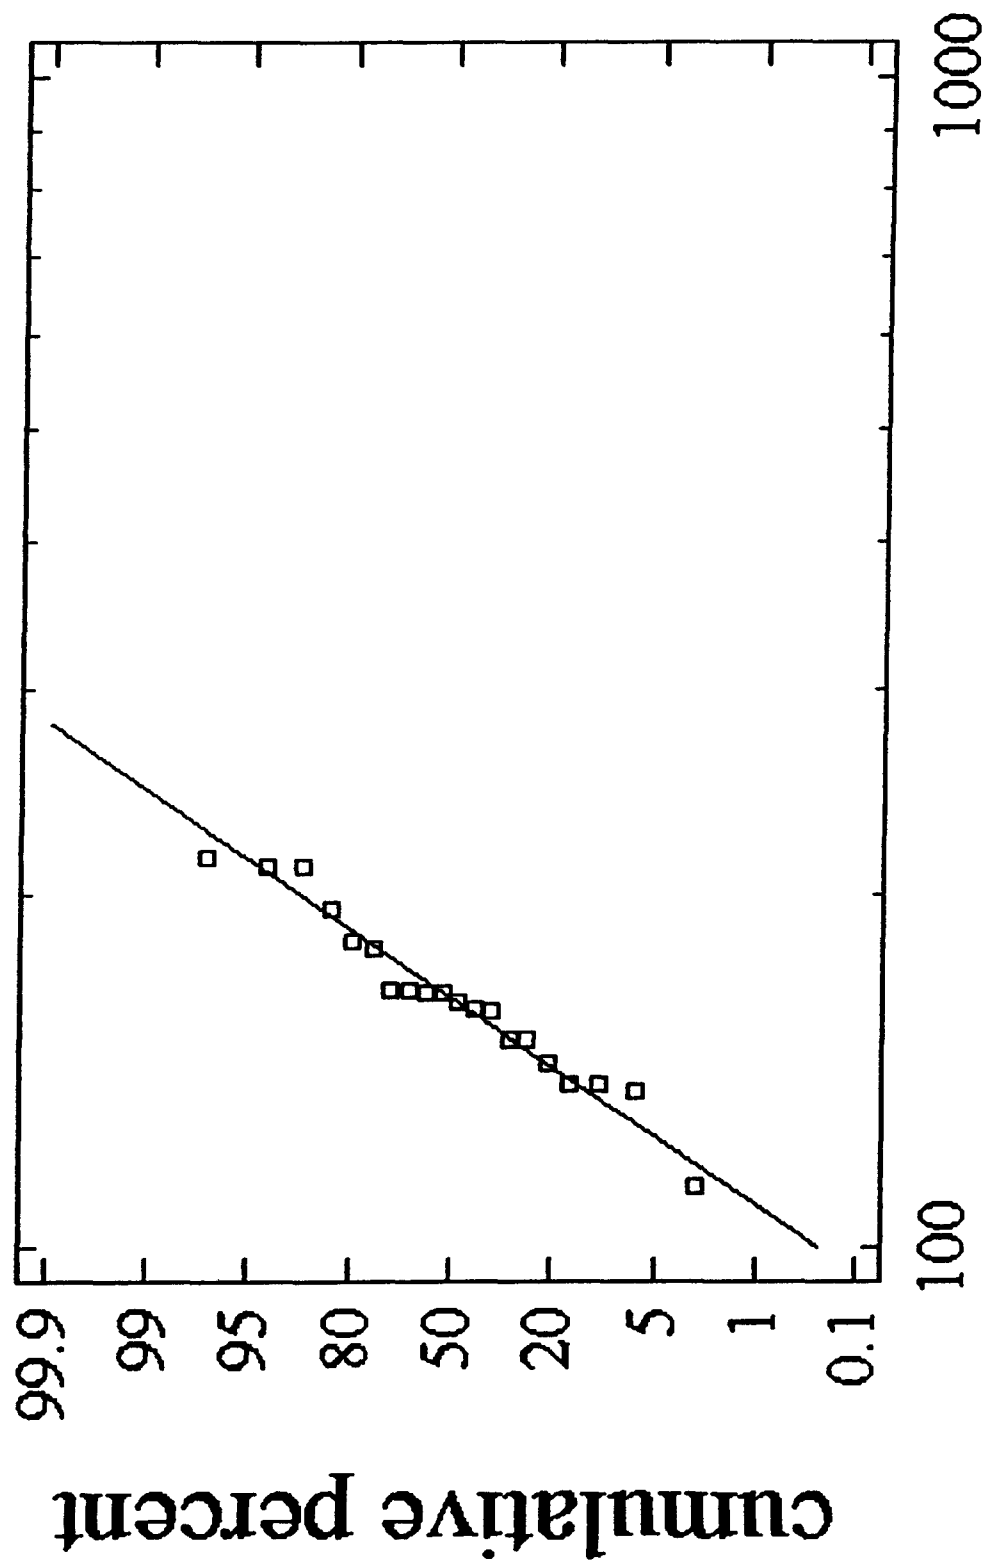
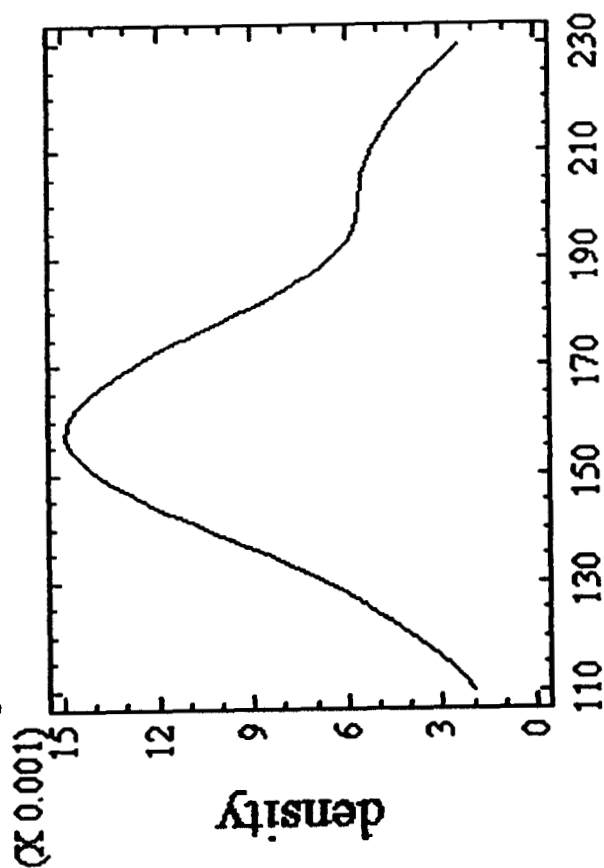
Lognormal Probability Plot

Since the smallest p-value amongst the tests performed is less than 0.10, we can reject the idea that Survey Unit 779017 dpm comes from a lognormal distribution with 90% confidence.
